Manhole Inspection Summary

Manhole # S37WW_013MH

Insp Date: **4/23/07 10:41 AM**

Location Address: **3100 GREENMOUNT AVE**

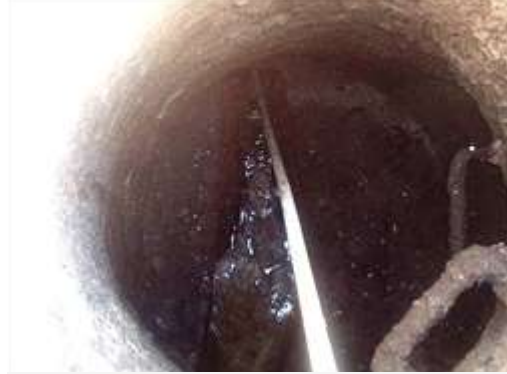
Top View

Bench and Channel debris.

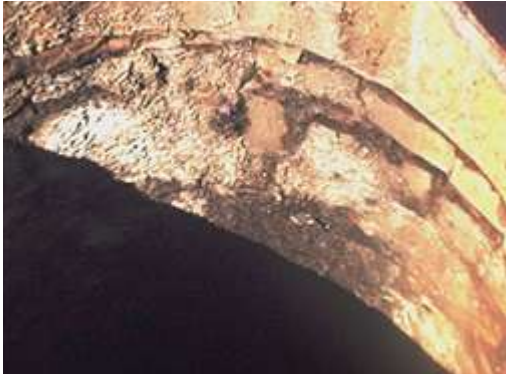
Defect

Frame leaks. Adjustment deterioration and infiltration - other side.

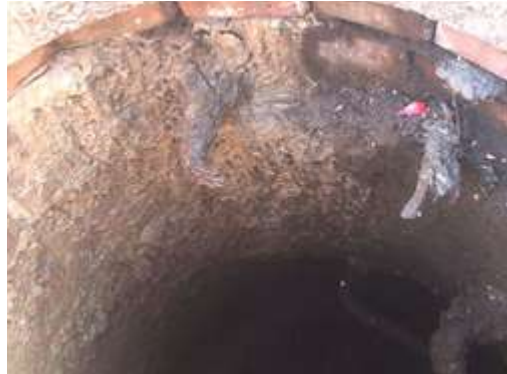
Defect

Corroded and missing steps. Frame leaks. Adjustment deterioration and infiltration.

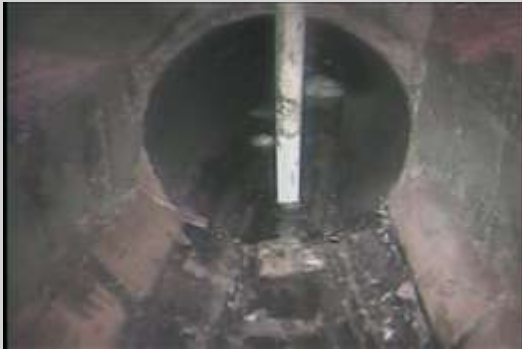
8 in. Circular Gravity Sewer Pipe Out @ 12 O'Clock

Deposits: ☐ None ☒ **Mud** ☐ Sludge ☒ **Debris** ☐ Grease

Silt Depth: **0.5** (in.) Deposits Extent: **Light**

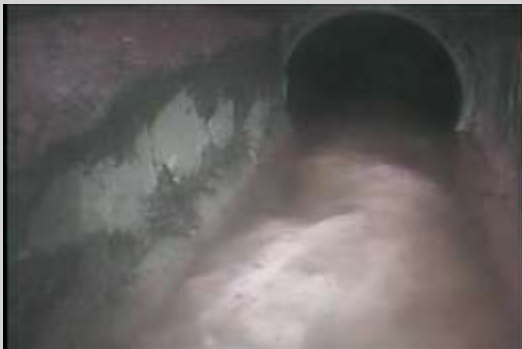
8 in. Circular Gravity Sewer Pipe In @ 7 O'Clock

Deposits: ☐ None ☐ Mud ☐ Sludge ☒ **Debris** ☐ Grease

Silt Depth: **0** (in.) Deposits Extent: **Light**
